Bureau of Air Safety Investigation

INVESTIGATION REPORT

9401043

DOUGLAS DC-3 VH-EDC
Botany Bay, New South Wales
24 April 1994

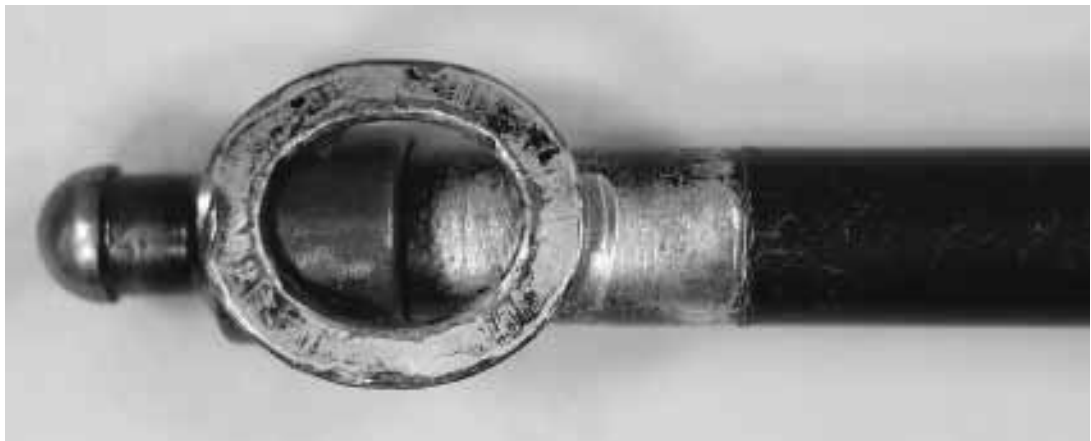
1. On removal of the no. 3 cylinder inlet valve pushrod cover, pushrod and tube, excessive wear of the pushrod and of the cylinder where the pushrod enters the valve rocker housing was apparent. Further inspection revealed that one of the thrust washers which are fitted either side of the rocker arm on the rocker shaft was not fitted to the shaft. The thrust washer subsequently fell out of the valve rocker housing. The loose washer was oval in shape, having sustained impact damage during engine operation. At the last time of fitting, the shaft was installed but failed to engage the washer which subsequently was left within the rocker housing. The housing, through which the cover tube is located and through which the pushrod operates, was damaged at the point coincident with the damage on the pushrod.

The cylinder, complete with inlet and exhaust valve assemblies, inlet valve pushrod and cover and the damaged washer, was examined. The aim was to determine when and how the washer was damaged, and the likelihood of this loose component jamming the inlet valve in the open position. The rocker arm end of the pushrod contained heavy rub marks which penetrated the pushrod to about 25% of the wall thickness. The curved edges of these wear marks matched the deformed washer. There was also a curved depression within the rocker housing, adjacent to the inlet pushrod tube, which matched the shape of the deformed washer. Plastic deformation of the cylinder head material into this depression indicated the nature of the compressive loads applied to the pushrod. The amount of material rolled inside the depression mark suggested that the washer had been in this position for a considerable period. With the washer located in the depression, it could become jammed between the cylinder head and the pushrod, thus preventing the inlet valve from closing. The amount of valve lift provided by the jammed pushrod was approximately 4 mm.

Figure 2. The deformed thrust washer and the deep rub marks on the push rod.

The firing of the spark plugs on the cylinder while the inlet valve was jammed open would cause the fuel-air mixture in the common induction system to ignite. In addition to the loss of power from the no. 3 cylinder, the resultant disruption of the fuel-air mixture to the remaining cylinders would cause irregular engine operation and a reduction in power. The engine manufacturer has advised that a power loss of up to 50% could result, accompanied by backfiring through the intake manifold and carburettor. Fire residues and soot deposits were found in the no. 3 cylinder intake cavity and the adjacent intake manifold. Examination of the air intake assembly revealed deposits of black soot within the carburettor air intake and on the debris screen, indicative of backfiring, and possible intake fire.

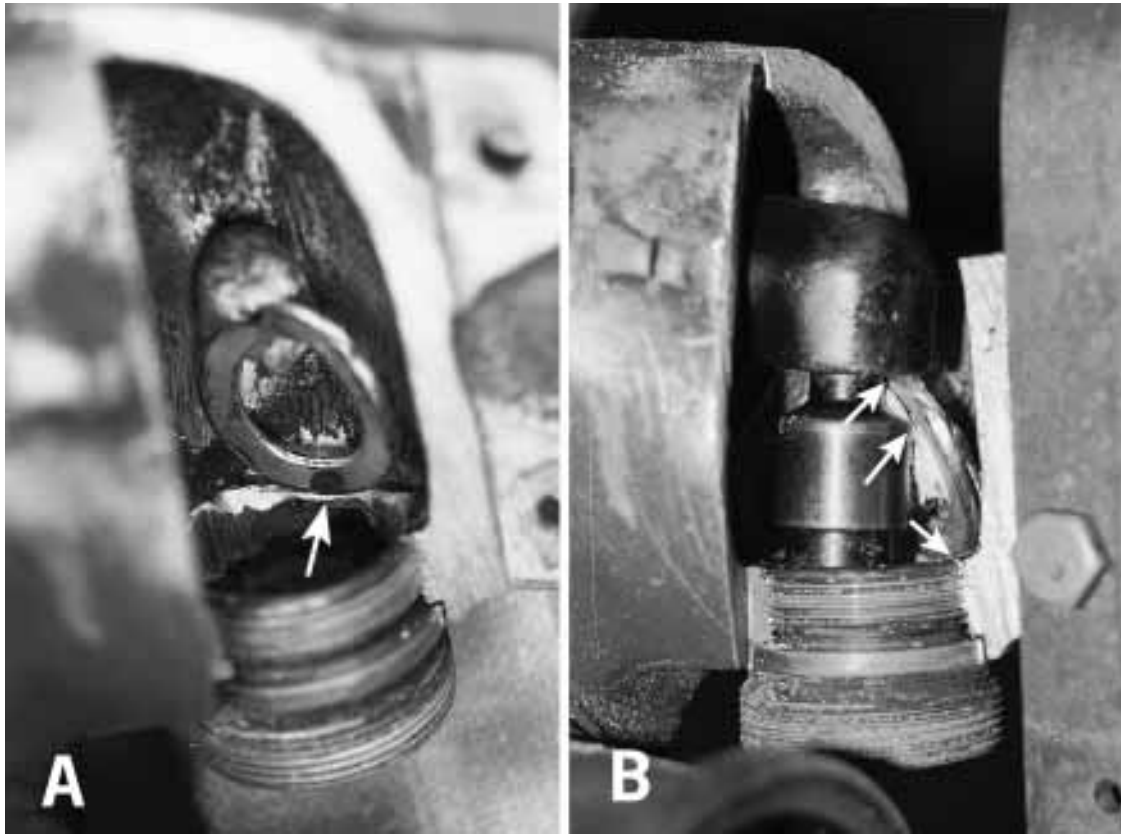
Figure 3.

- (A) The mark on the edge of the cylinder head rocker assembly housing is shown. Its shape matched the shape of the thrust washer.
- (B) The thrust washer with one side forced against the rocker assembly housing, while the opposite side is jammed between the rocker arm and the push rod upper end. To facilitate this demonstration, an adhesive was used to hold the washer in position.

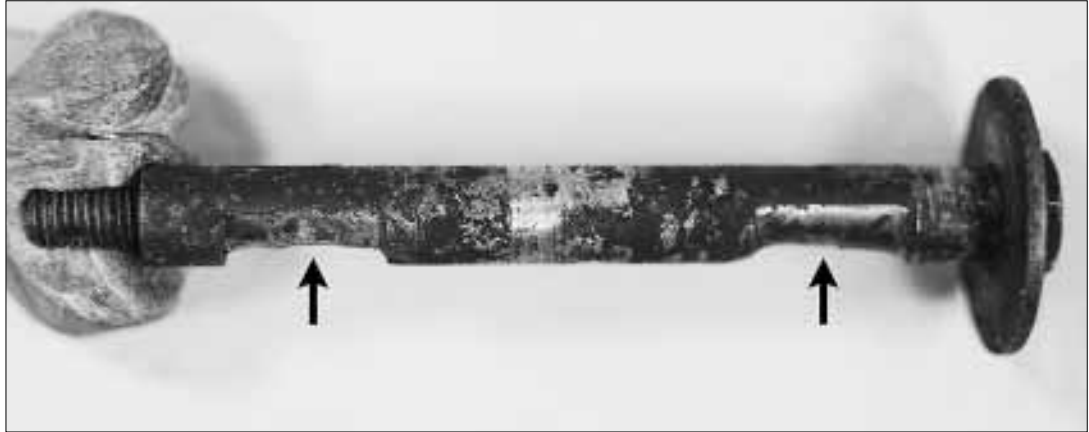
3. The propeller governor pitch control cable 90° pulley block securing bolt was excessively worn. There was a certification on the periodic inspection worksheets at the time of issue of the current maintenance release on 25 February 1994, some 6–8 operating hours prior to the accident, that the assembly had been renewed.

Figure 4. The worn pulley block securing bolt.

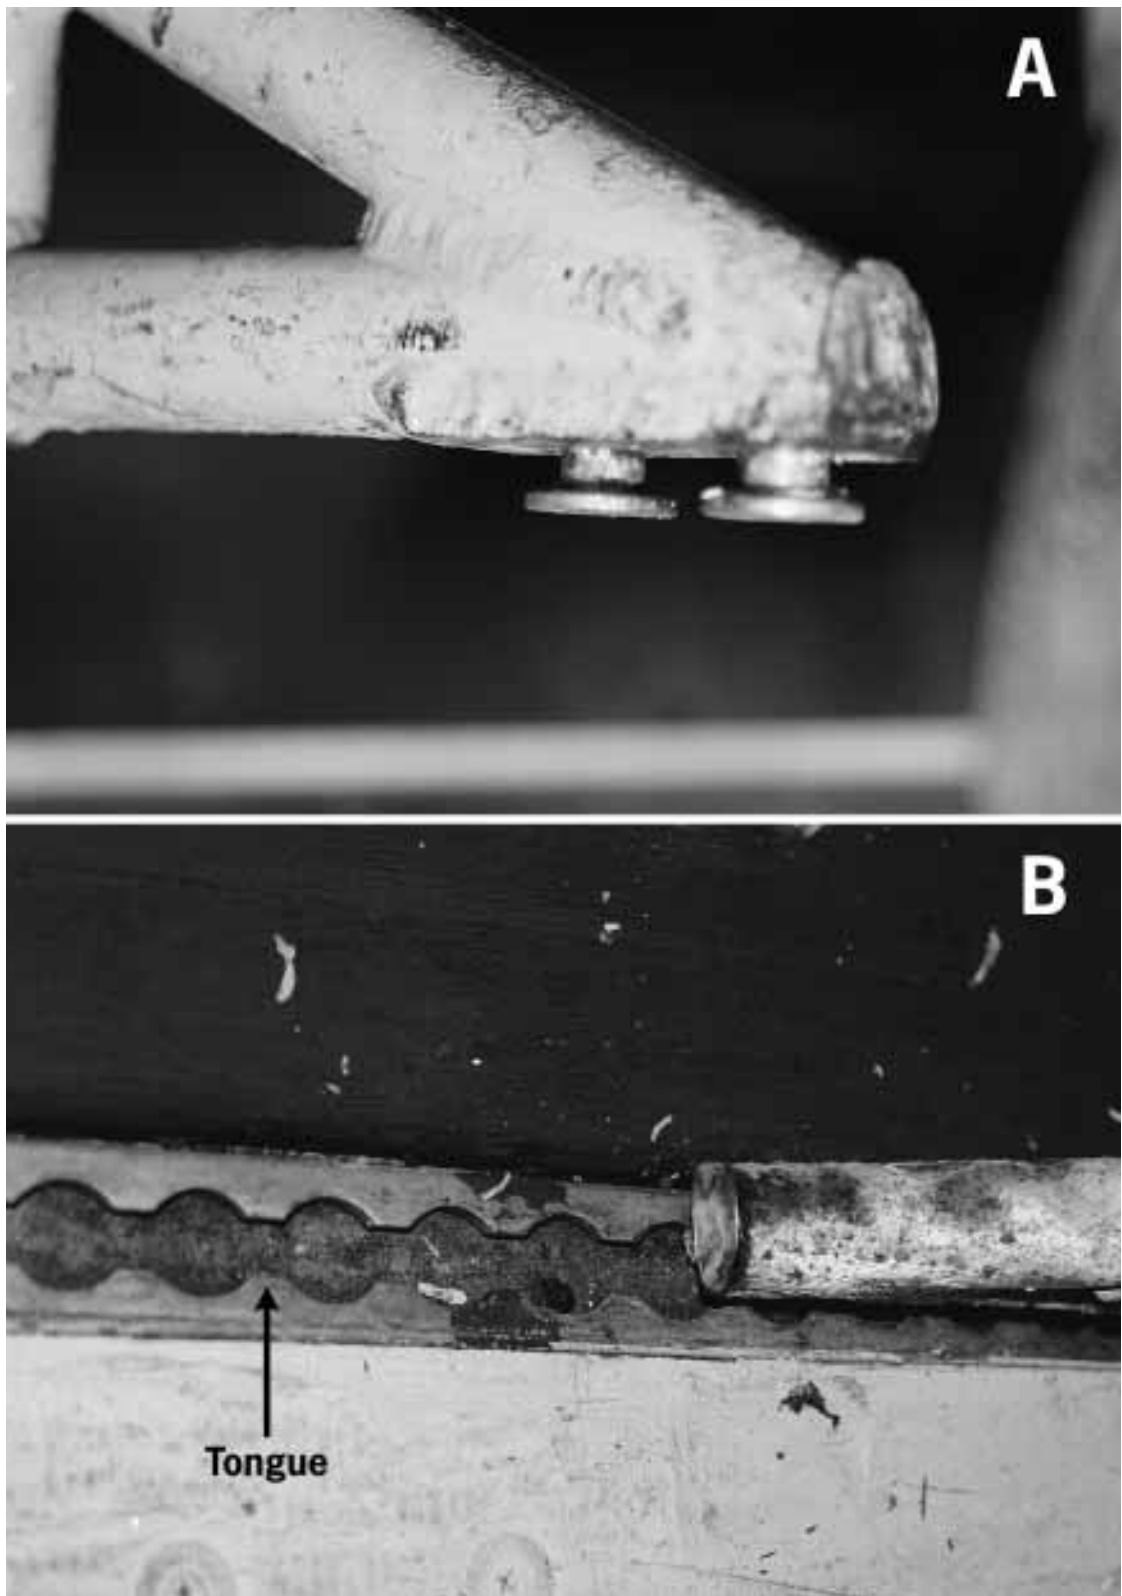
Figure 6.

At impact, one seat belt detached from seat 3D, and seat rows 1C/D, 5A/B and 6A/B separated from the seat rail on the outboard side. Examination of these seats indicated that the three outboard feet of seat rows 5 and 6 were not in the seat rail. The positioning pins were operational and there was no damage to either the seat rail or the feet of the seat. The rear two

outboard feet of row one were not in position. No damage had occurred to either the seat rail or feet and the positioning pin was stowed, with the adjusting mechanism absent.

(A) The lower arm of the seat structure showing the two rear locating feet.

(B) The Douglas track floor rail into which the feet of the passenger seat locate, under the rail tongue. The seat is retained in position by a spring-loaded locating pin which engages in the rail recess.

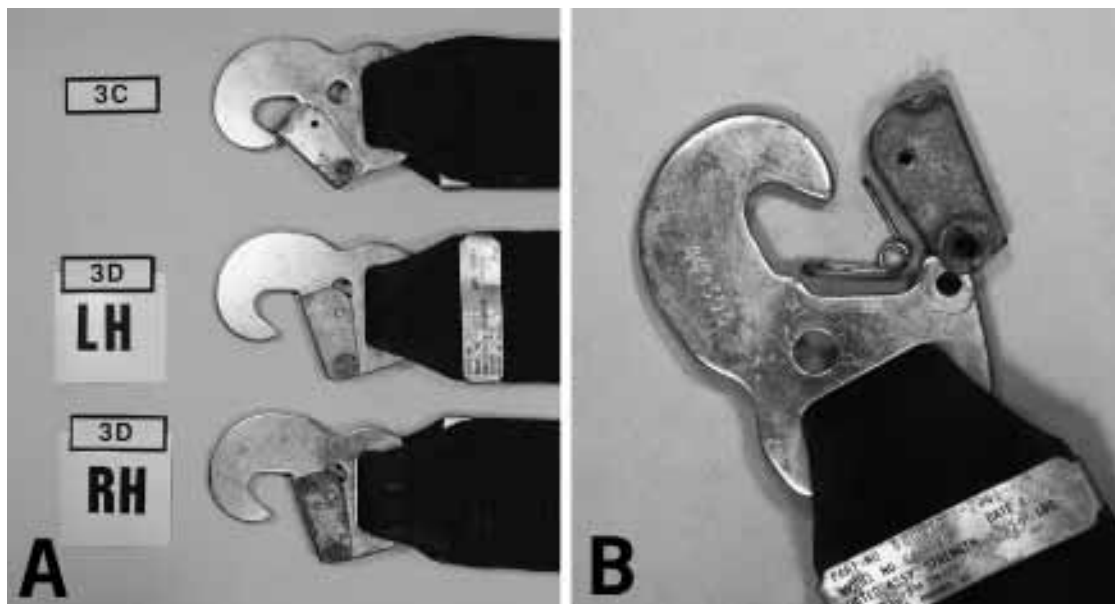
Figure 7.

In addition to the seat belt which detached from a seat, three further seat belt fixtures were found to be deficient. The outboard half of the 3D seat strap was dislodged, and the spring-loaded gate which secures the fitting to the seat structure was found to be jammed in the open position. The gate was also jammed open on the inboard side of 3D. Both springs were absent, as they also were on the outboard side of the belt for seat 2C. The gate itself was deformed and was partially open. The spring was present on the outboard seat attachment for seat 5C; however, the gate was deformed and partially open. Examination of the belts and their fittings did not indicate any pre-existing fault.

(A) The seat 3D belt straps as found, with the attachment gates jammed in the open position. The seat 3C strap is shown to demonstrate the position of a correctly functioning gate.
