ACCIDENT INVESTIGATION REPORT

VISCOUNT 720C AIRCRAFT VH-RMQ
NEAR PORT HEDLAND WESTERN AUSTRALIA

31ST DECEMBER 1968

AIR SAFETY INVESTIGATION BRANCH
DEPARTMENT OF CIVIL AVIATION

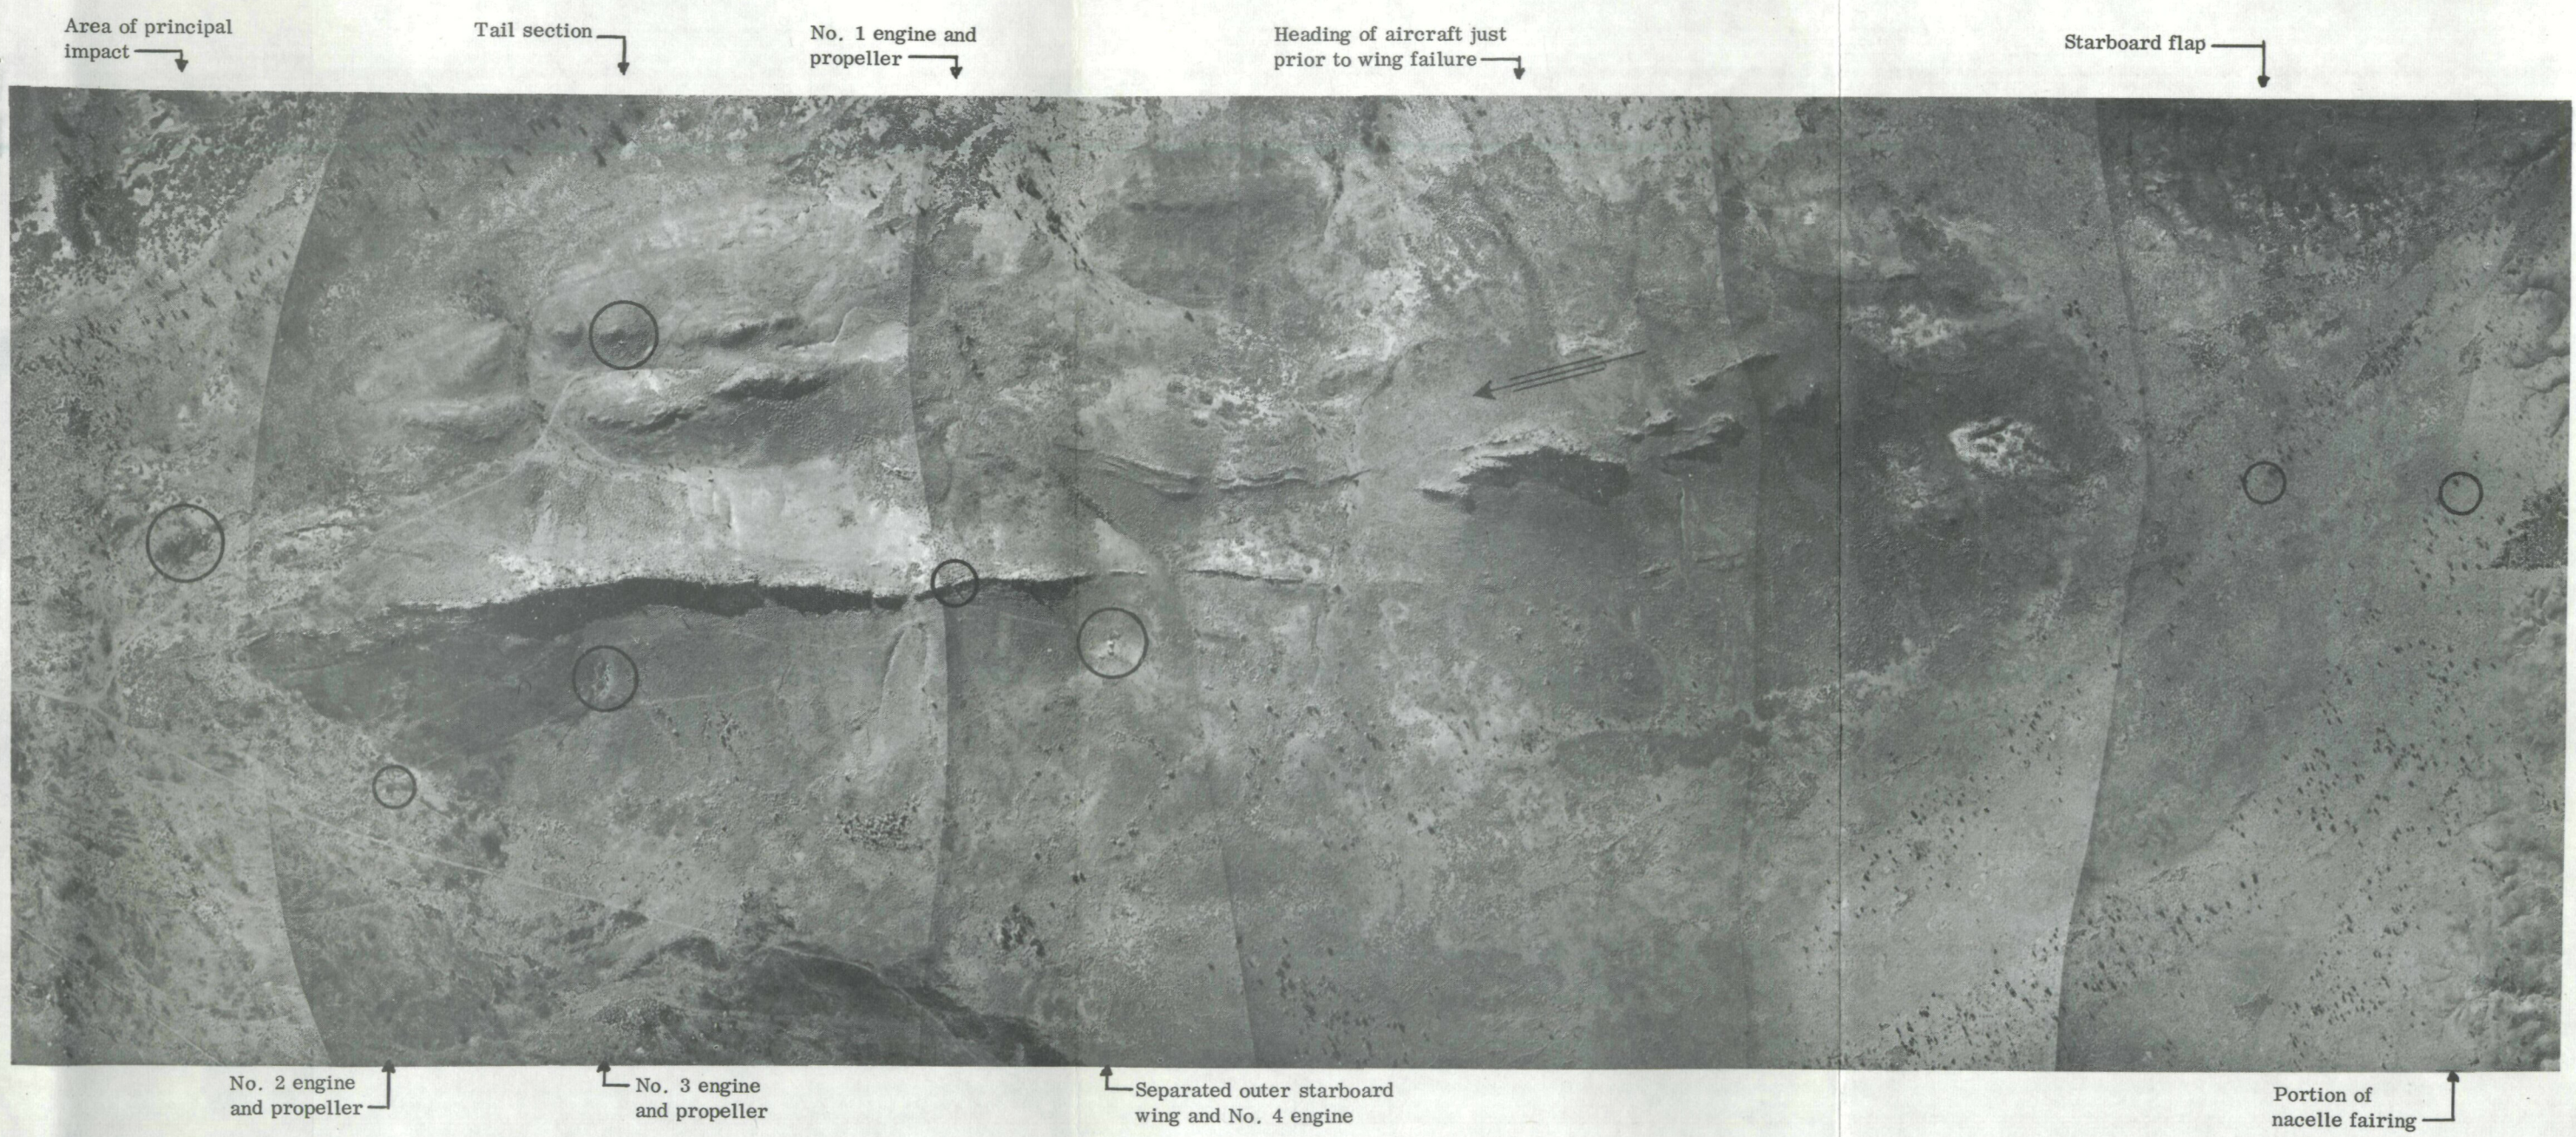
approximately bisected the minor dimension of this area. At Appendix D there is an aerial photograph of the area over which the wreckage was distributed which also shows the points at which major items were found.

Aerial View of Accident Site Showing Locations of Principal Items of Wreckage

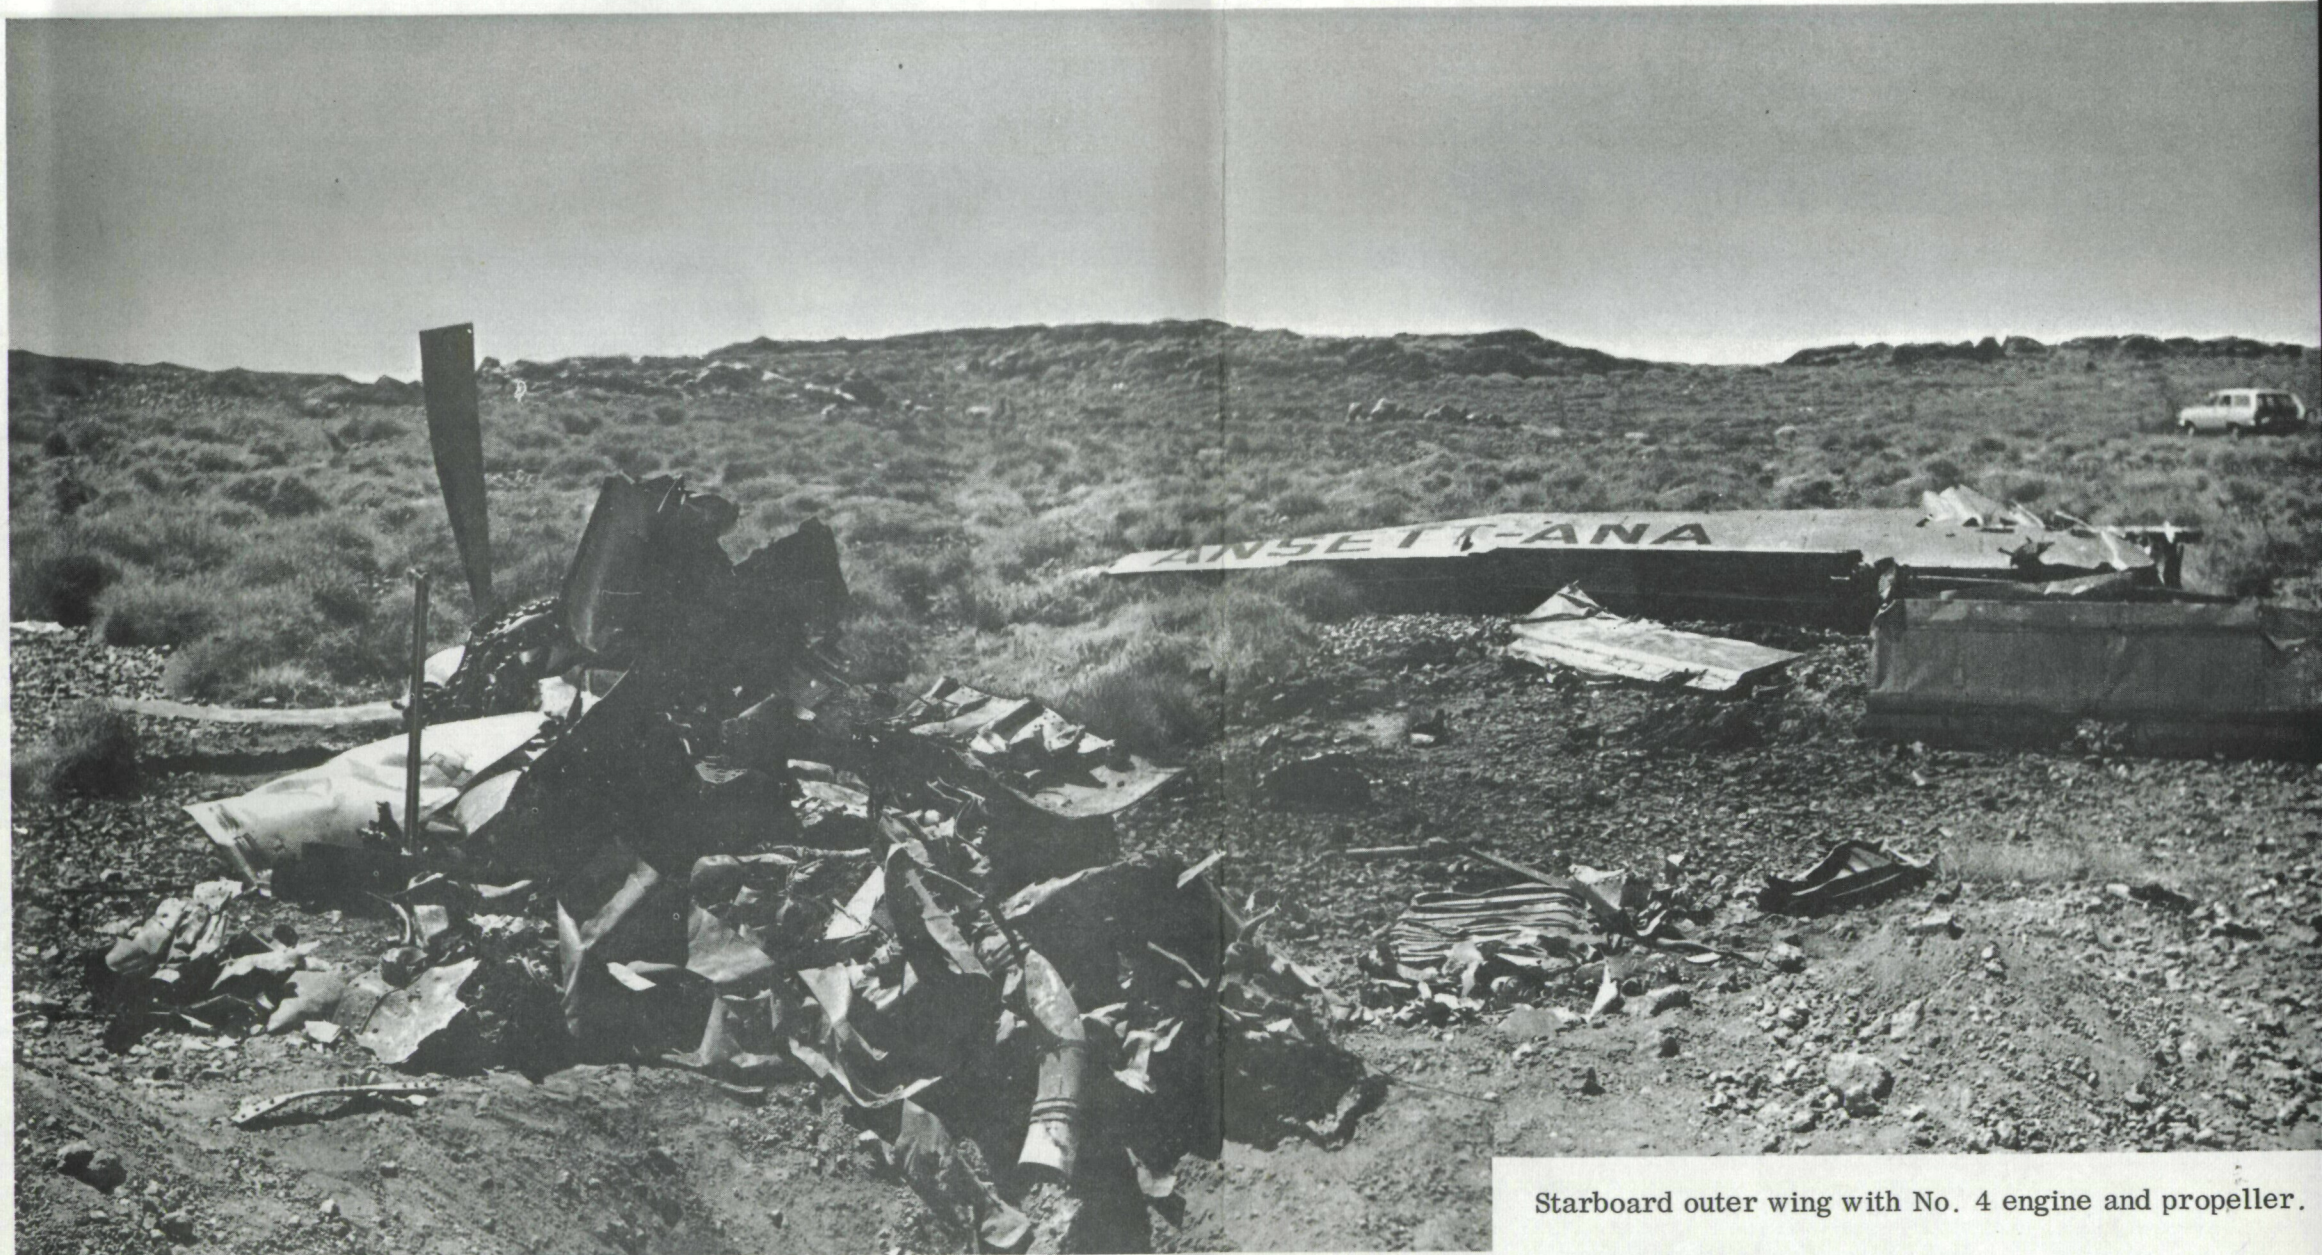
The most significant feature of the wreckage distribution was the fact that the whole of the starboard wing outboard of the inner or No. 3 engine and including the No. 4 engine, its propeller and supporting nacelle structure, were found close together, but separated from the point of principal impact by some 3,000 feet. None of these components had been affected by fire and, although the No. 4 engine, the nacelle structure and the inboard portion of the wing had been severely damaged by ground impact, there was relatively little damage to the outer wing section. A photograph of these items of wreckage is at Appendix F. Nos. 1, 2 and 3 engines were also found at separate locations and, generally, they lay between the point where the starboard outer wing was found and the point of principal impact. Some of these items of wreckage were affected by grass fires started by the accident. The tail section and rear fuselage of the aircraft was also found at a point some 1,600 feet south of the main wreckage. The earliest items in the wreckage trail, having regard to the aircraft's direction of movement, were sections of flap and secondary structure originating from the structural area close to the point of separation of the starboard wing from the aircraft. More than 90 significant items of wreckage were recovered outside the impact areas of the major assemblies already referred to. It was quite apparent from the distribution of wreckage that the aircraft structure had failed in flight.

Starboard outer wing with No. 4 engine and propeller.

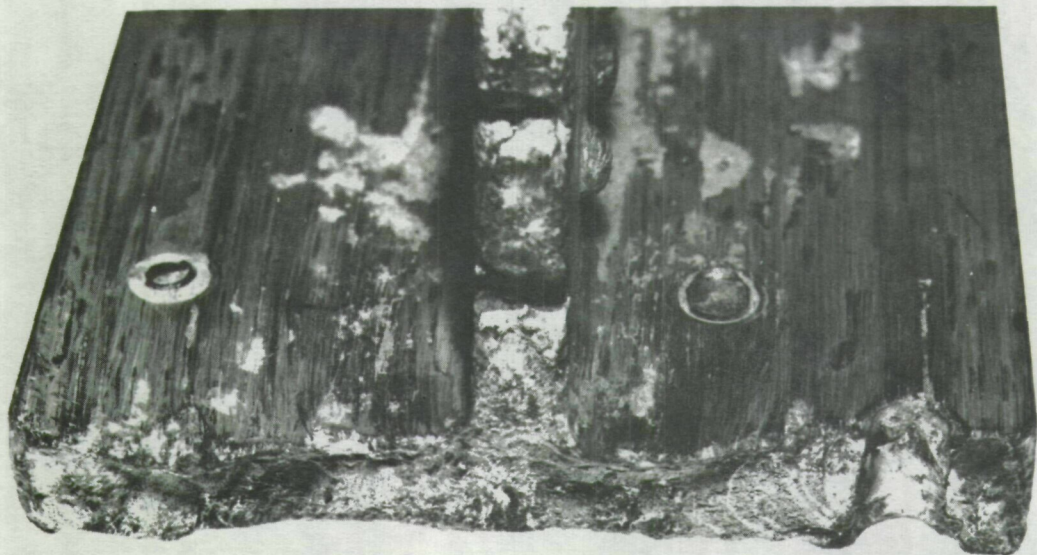
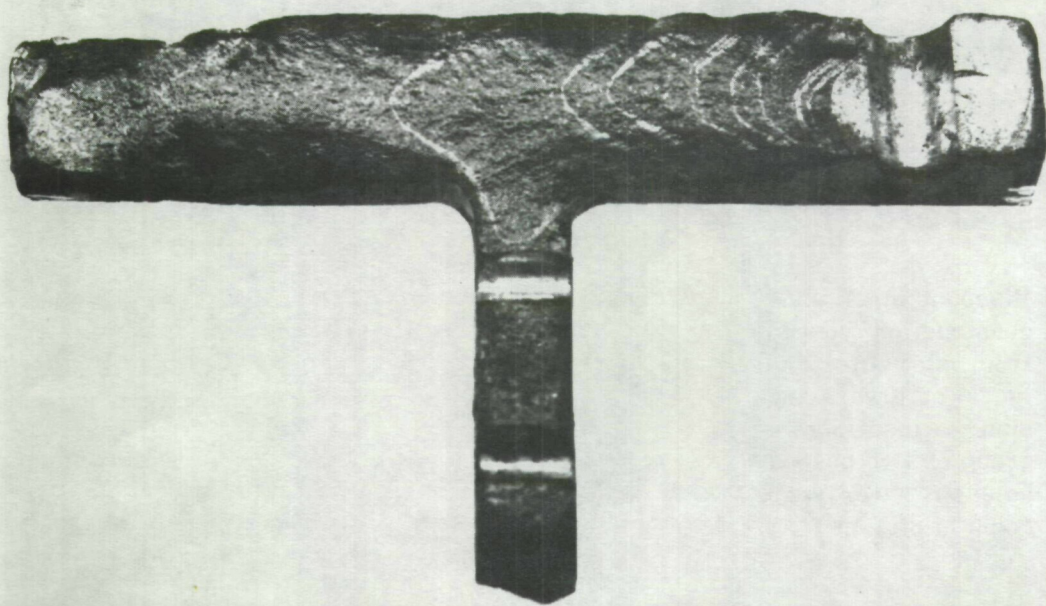
It was determined that the fatigue cracking and primary failure of the starboard inner wing main spar lower boom occurred at Station 143 which almost coincides with the outboard edge of No. 3 engine nacelle. A general view of the internal wing structure and an inset view of the main spar lower boom at Station 143 are at Appendix H. The components of the starboard wing in this area were re-assembled in Melbourne and, although the work was limited by the considerable damage sustained by these components, no evidence of any prior defect was found other than that which occurred at Station 143 in the main spar lower boom.

At least four small fatigue cracks initiated within the bore on the rear surface of the bolt hole at Station 143 and they propagated towards the trailing edge of the boom. These several small cracks joined together and the propagation continued as a single fatigue crack. At some later time, multiple cracking also commenced on the forward surface of the hole and again these joined to form a single crack propagating towards the leading edge of the boom.

Outboard (upper) and inboard (lower) faces of the fracture at Station 143 of the starboard inner wing lower spar boom. (Approx. actual size)

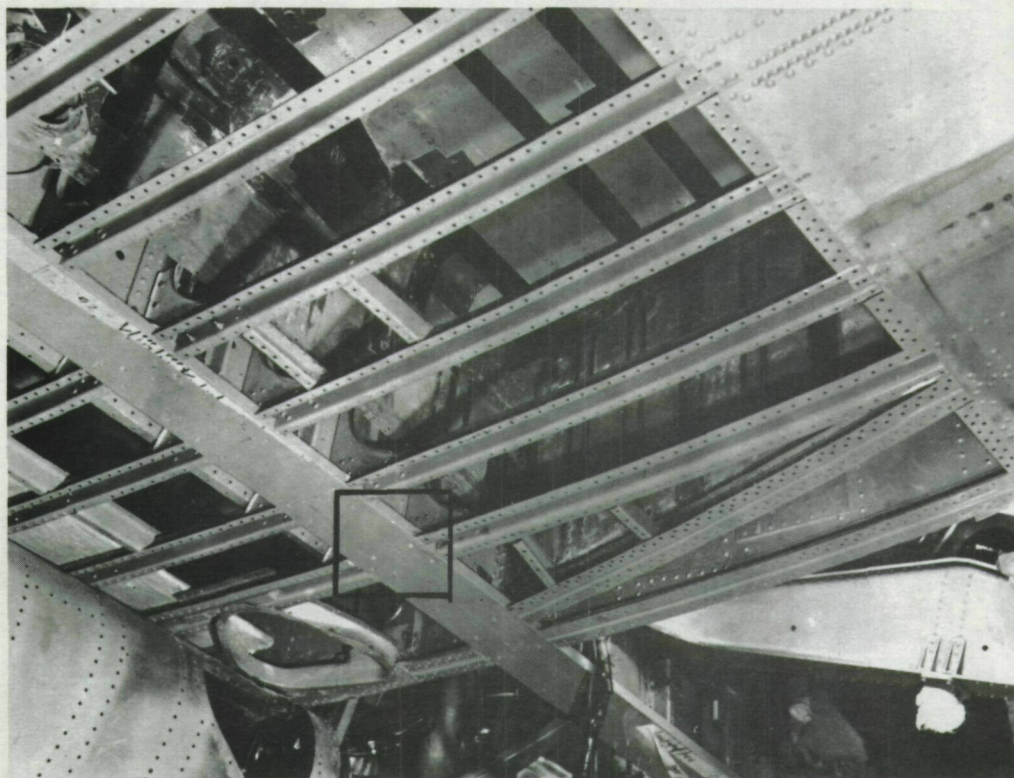
The fatigue cracking and subsequent failure at Station 143 had occurred through the rear bushed hole of a group of five in the boom at this point. The inset view in Appendix H depicts these five holes but they are normally hidden from view by the lower wing skin and other components. The five bolt holes, of which the rearmost is at Station 143, are to permit attachment of

Viscount inner wing construction viewed from below after removal of lower wing skin. (Inset shows group of five bushed holes in lower spar boom at Station 143)

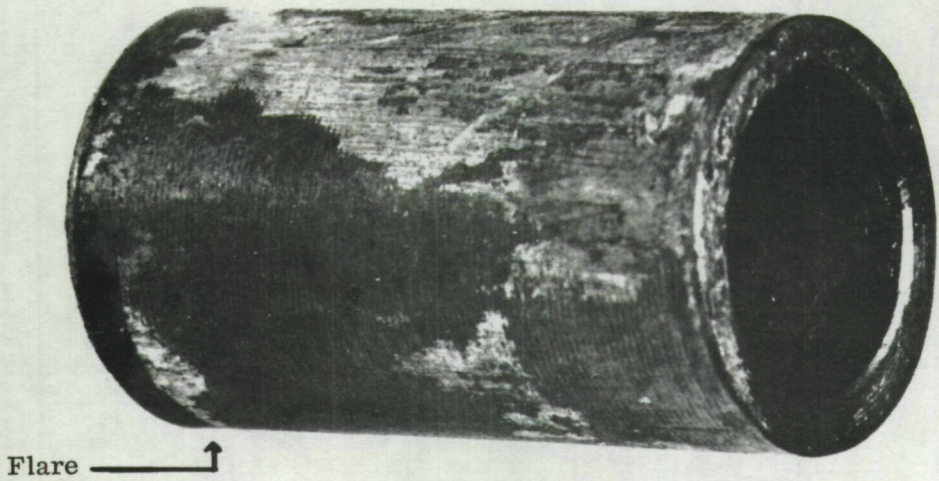
In comparing the found dimensions of the Station 143 bush with those prescribed by the manufacturer in Drawing No. 70103/3345 issue BIII for production of these bushes a number of differences was noticed as follows -

Figure 1 Flared bush from Station 143, starboard inner wing lower spar boom. (Magnification 5 diameters approx.)

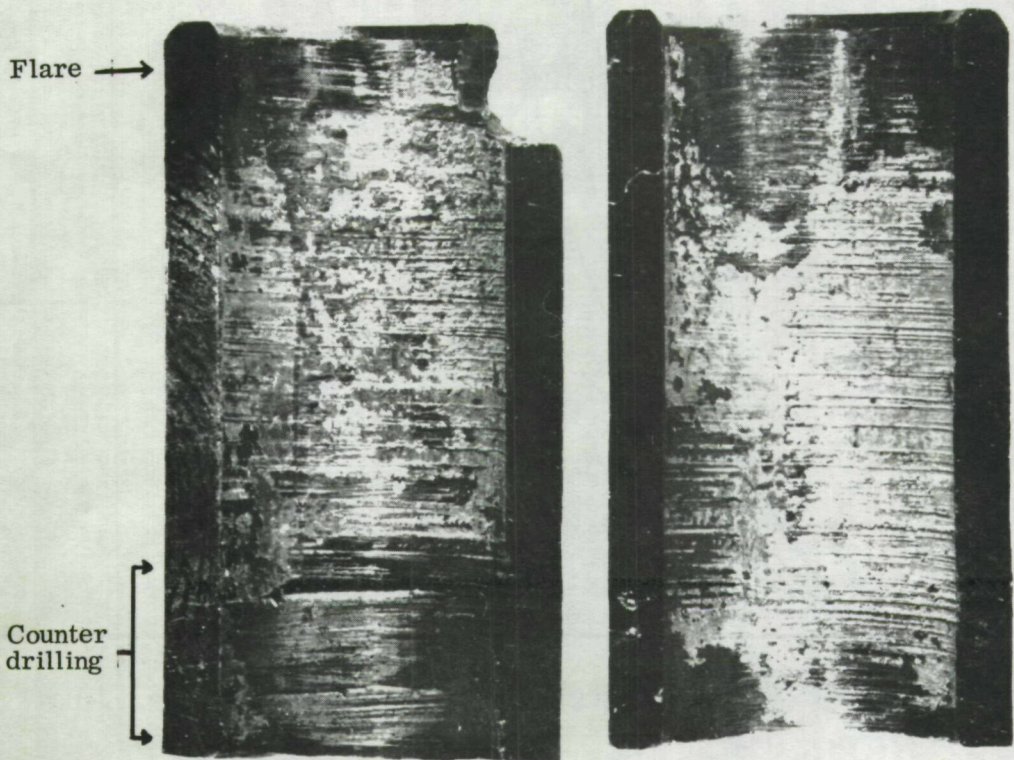
When the internal surface of the bush was examined it was noticed that, on one side of the bore and commencing at the lower end as installed in the aircraft, there were relatively coarse machining marks which had removed the cadmium plating and 0.006 inches of bush material. These marks were consistent with the bush having been counter-drilled from its lower end, subsequent to manufacture. These counter-drilling marks are illustrated in Figure 2 of Appendix I. Similar signs of post-manufacture counter-drilling were found in bores of two other bushes in the group of five located at and about Station 143. In these bushes the amount of material removed was 0.006 and 0.015 inches.

Figure 2 Counter-drilling in bore of bush as seen after sectioning

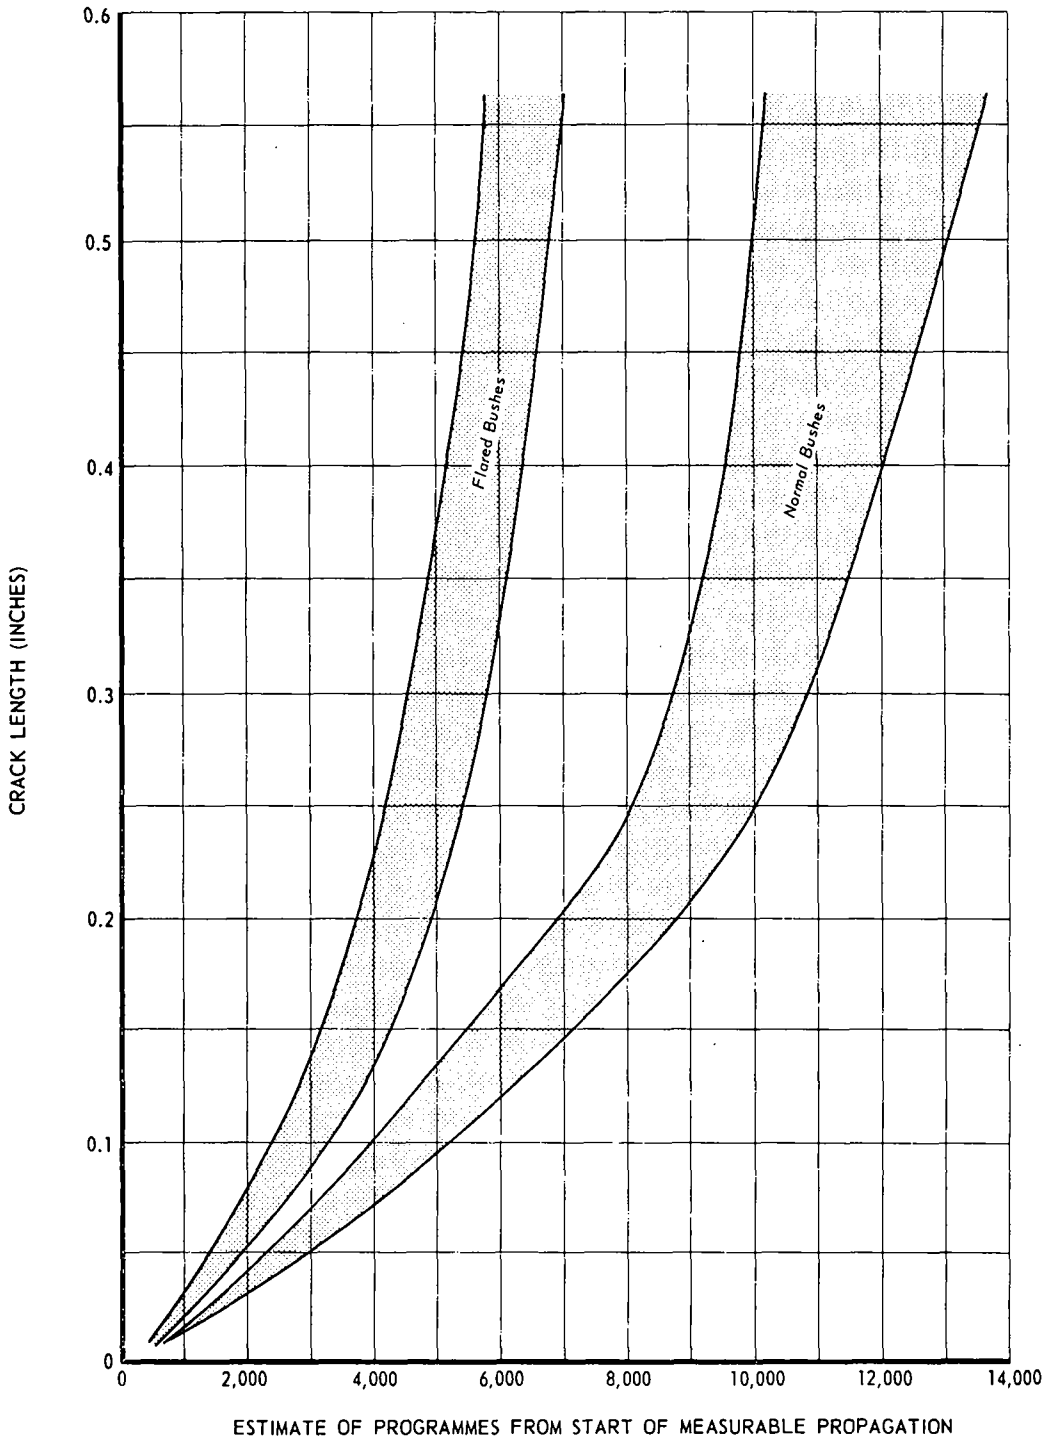
APPENDIX J

The manufacturer's report AL/MAT/3054 provided, in a number of cases, fatigue crack micro-progression rates in terms of the number of programmes per 0.001 inches progression at known crack lengths. These have been integrated and re-plotted with a common origin in Appendix J and provide a comparative estimate of crack propagation rates between holes with flared bushes and holes with normal bushes. Although there is a degree of estimation in this graph, particularly in respect of the determination of time of actual crack initiation, the results show under the test conditions used that, up to a crack length of approximately 0.25 inches, the crack propagation rate for a specimen with flared bushes approaches twice that of a specimen with normal bushes. It was also estimated from extrapolation of the crack propagation data that, in each case considered, the crack started to propagate measurably at about two-thirds of the life to failure under the test cycle loading. The crack propagation rates which were obtained using electron microscope fractographs of the fracture surface in the VH-RMQ boom over a distance one to six millimeters from the crack origin are listed in the report ARL/APP.66. At similar crack lengths the relative crack propagation rates given in that report show good agreement with the crack propagation rate curve for flared bush specimens presented in Appendix J.

COMPARISON OF CRACK PROPAGATION RATES
FLARED AND NORMAL BUSHES

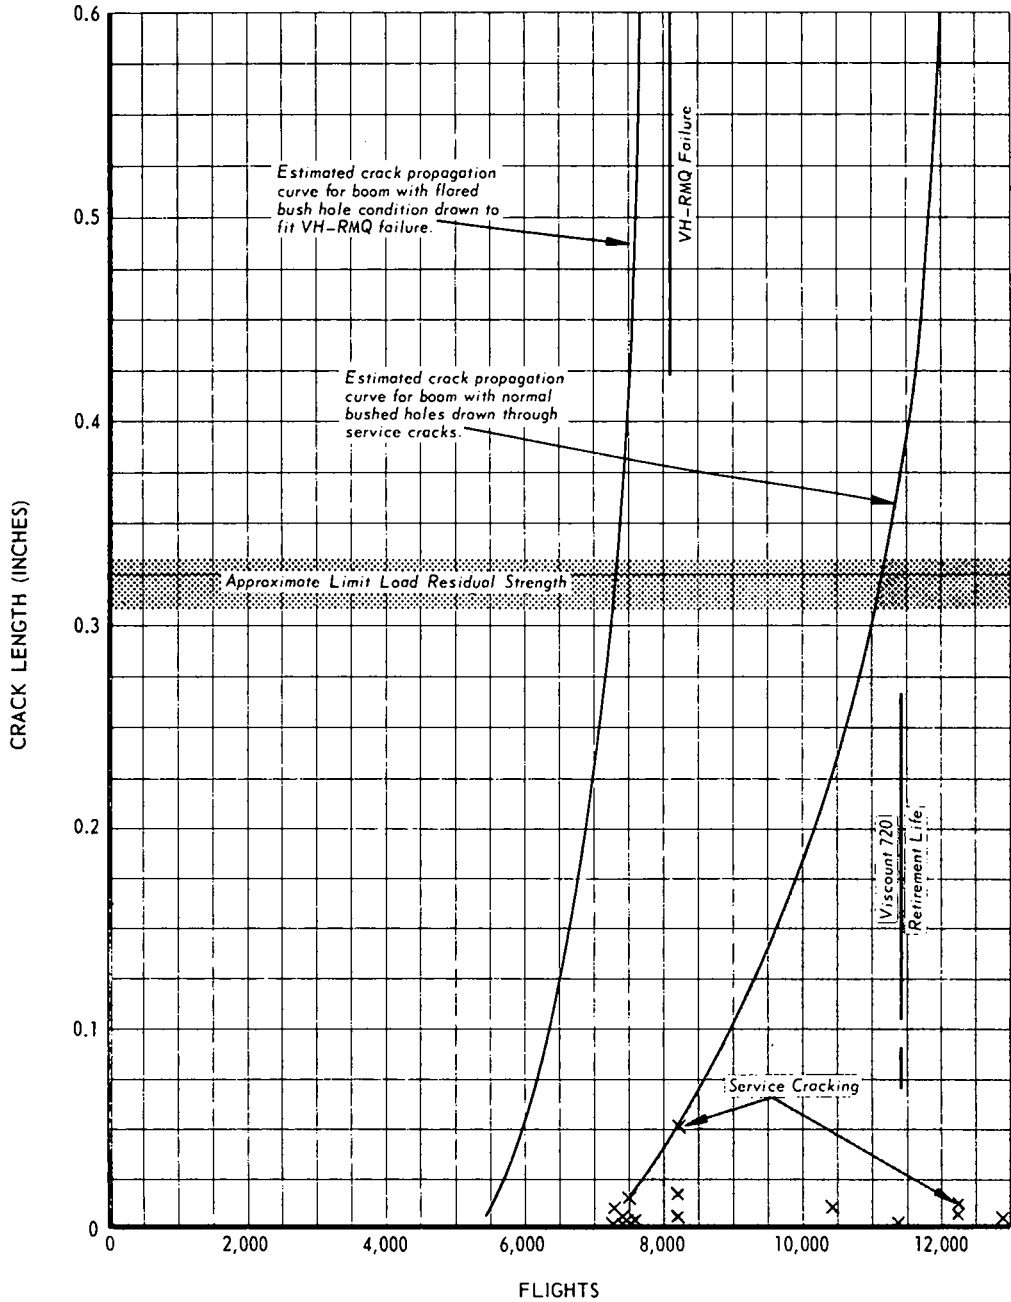
Appendix K depicts crack propagation rates in terms of flights both for the VH-RMQ boom and for other booms in which cracking has been discovered. On the basis of the known failure of the VH-RMQ boom at 8,090 flights,

APPLIED FACTOR, 2.44 TEST PROGRAMMES/FLIGHT
OBTAINED FROM TEST No. 9

ESTIMATED CRACK PROPAGATION RATES APPLIED TO
DTD 363 INNER WING SPAR BOOM SERVICE CRACKING
